University of Alberta

PERFORMANCE EVALUATION OF 2002 AND 2003 ALBERTA ASPHALT RUBBER PROJECT

Ashim Shivakoti

A thesis submitted to the Faculty of Graduate Studies and Research in partial fulfillment of the requirements for the degree of Master of Science

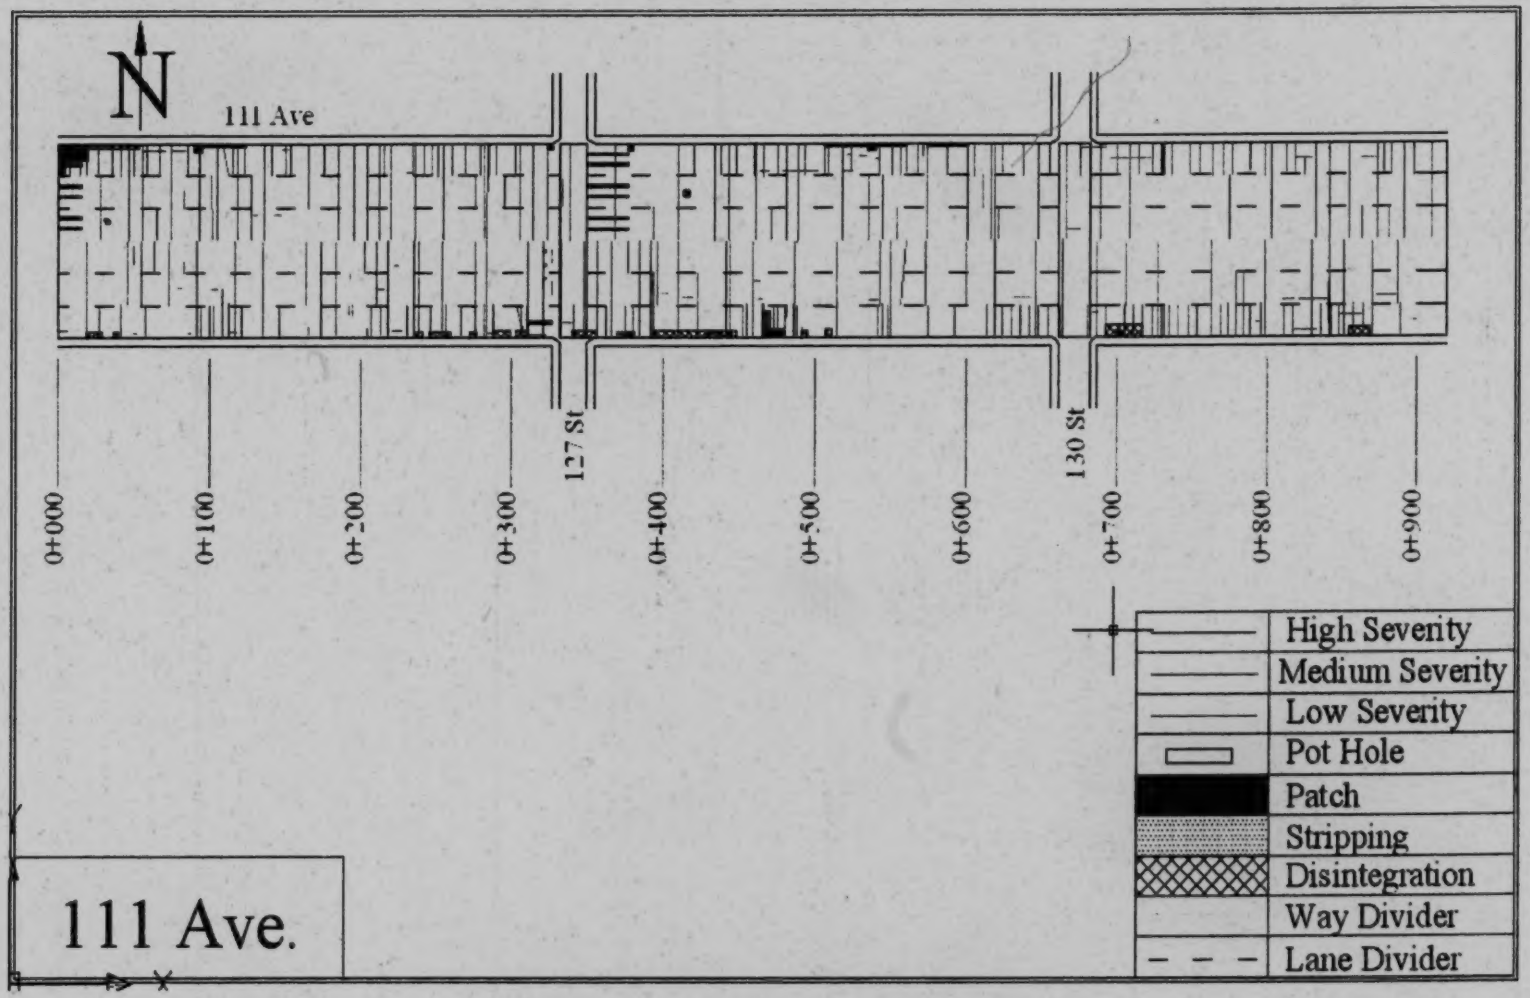
Figure 3.34 Crack measurements map at the 111 Avenue

The distress measurement at this project revealed a high occurrence of moisture related surface distresses (moisture damage, raveling). Most of the moisture damage and raveling were concentrated close to signalized intersections or the pavement edge. It is to be noted that the moisture damage was not significant in the 2002 Asphalt Rubber project locations. Transverse and longitudinal cracking were also significantly present at this project location.

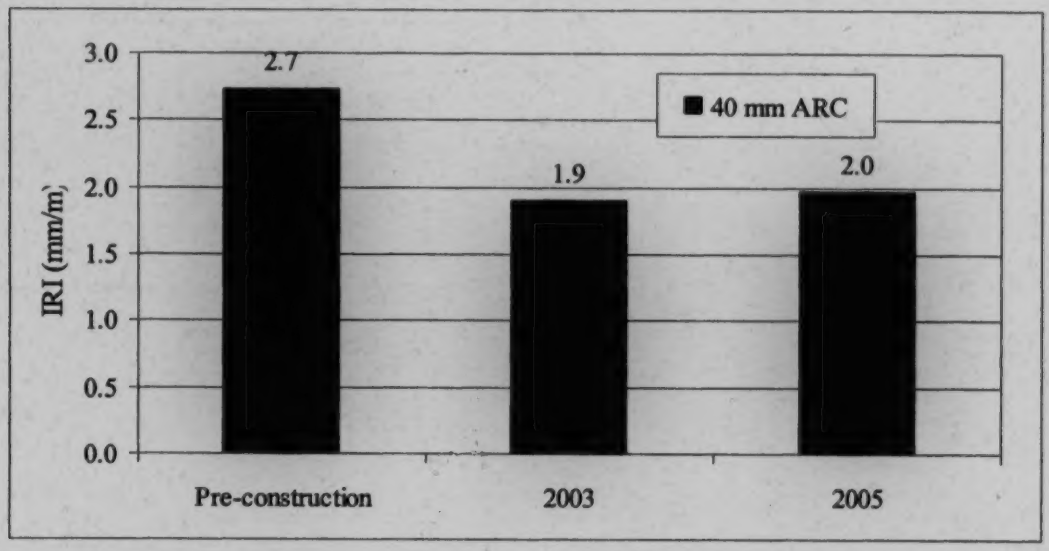
Figure 3.35 Summary of IRI measurement at the Baseline Road (2003) project location

The post-construction IRI measurements, at this project location, show a slight increasing trend. The rutting measurements, however, showed a decreasing trend. Again, this could be attributed to the change from one measurement to another and the fact that the accuracy of rut measuring equipment is $\pm$1 mm.

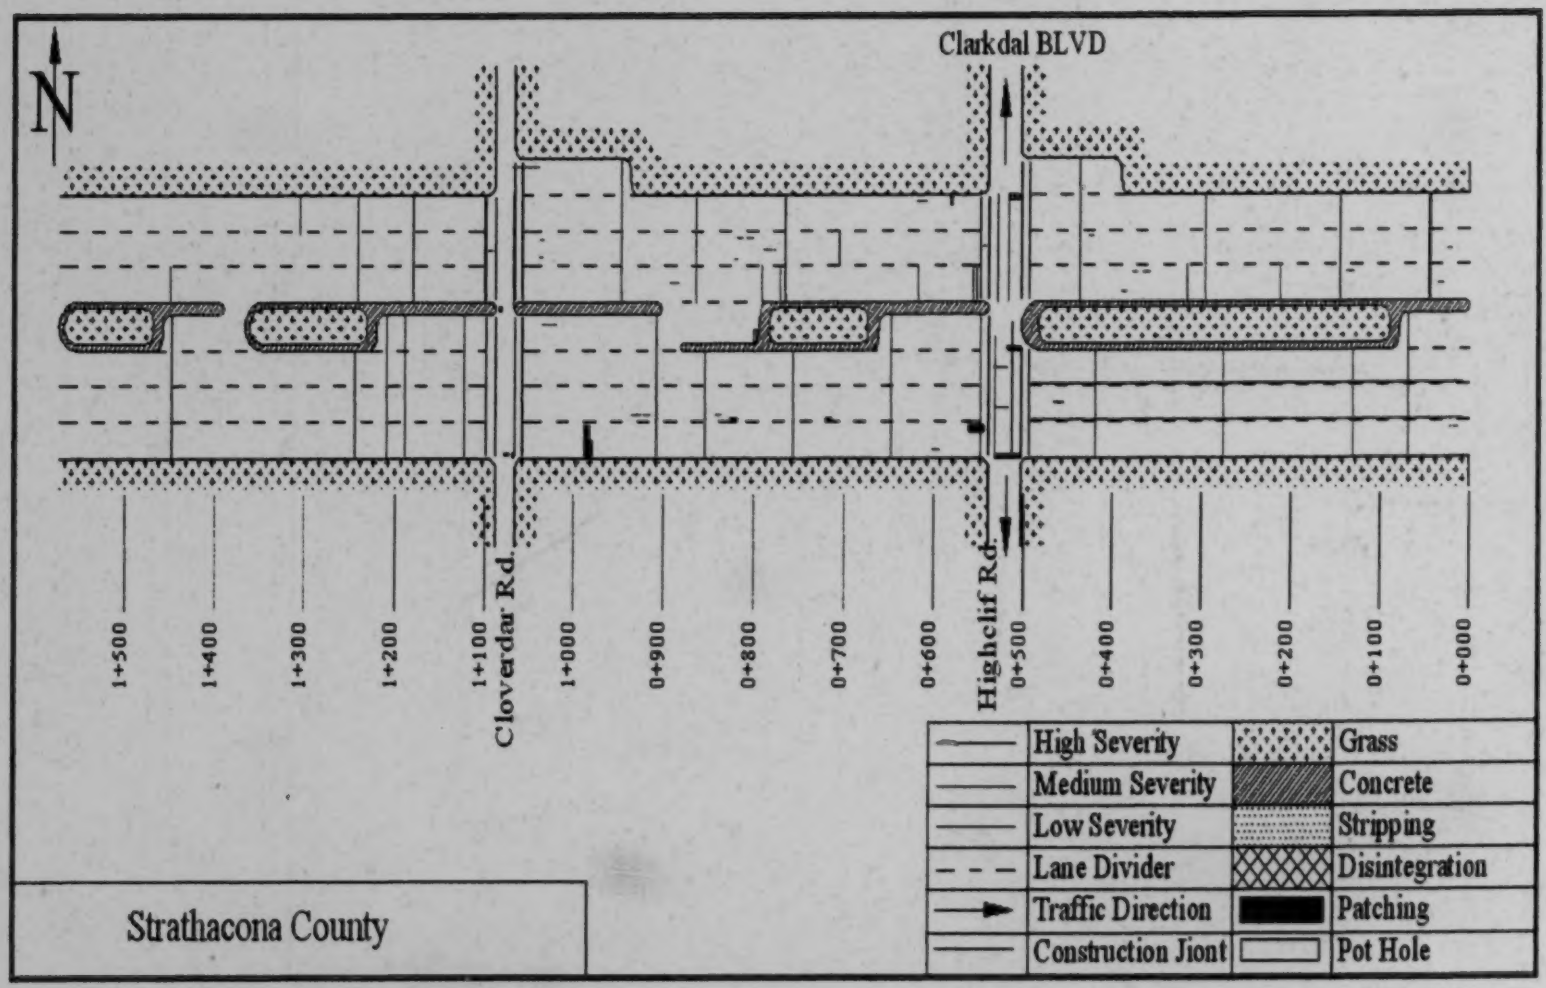
Figure 3.37 Crack measurements map at the Baseline Road (Chelsea Way to Highway 21)

Based on the visual measurement conducted during the summer of 2005, cracking does not appear to be a significant problem at this project location. However, as shown in Figure 3.37, moisture related distresses were observed close to the signalized intersections (intersection with Cloverbar road). The moisture related surface distresses at this project location are not as significant as in the Stony Plain Road or the 111 Avenue project locations.

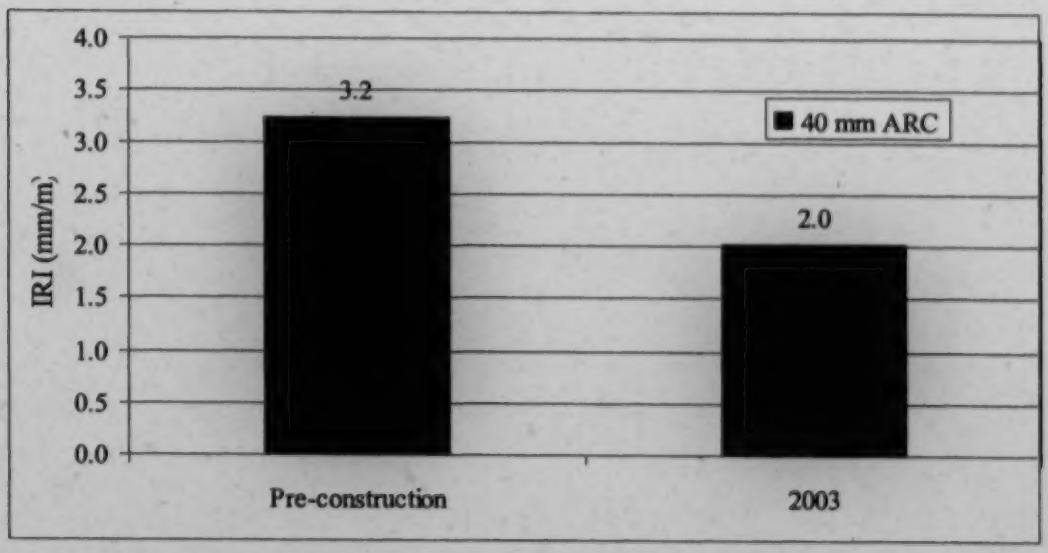
Figure 3.38 Summary of the IRI measurement at the Kaska Road project location

As illustrated the IRI measurement immediately after construction for this project location is almost close to 2 mm/m which can be considered slightly higher for a newly constructed pavement section.

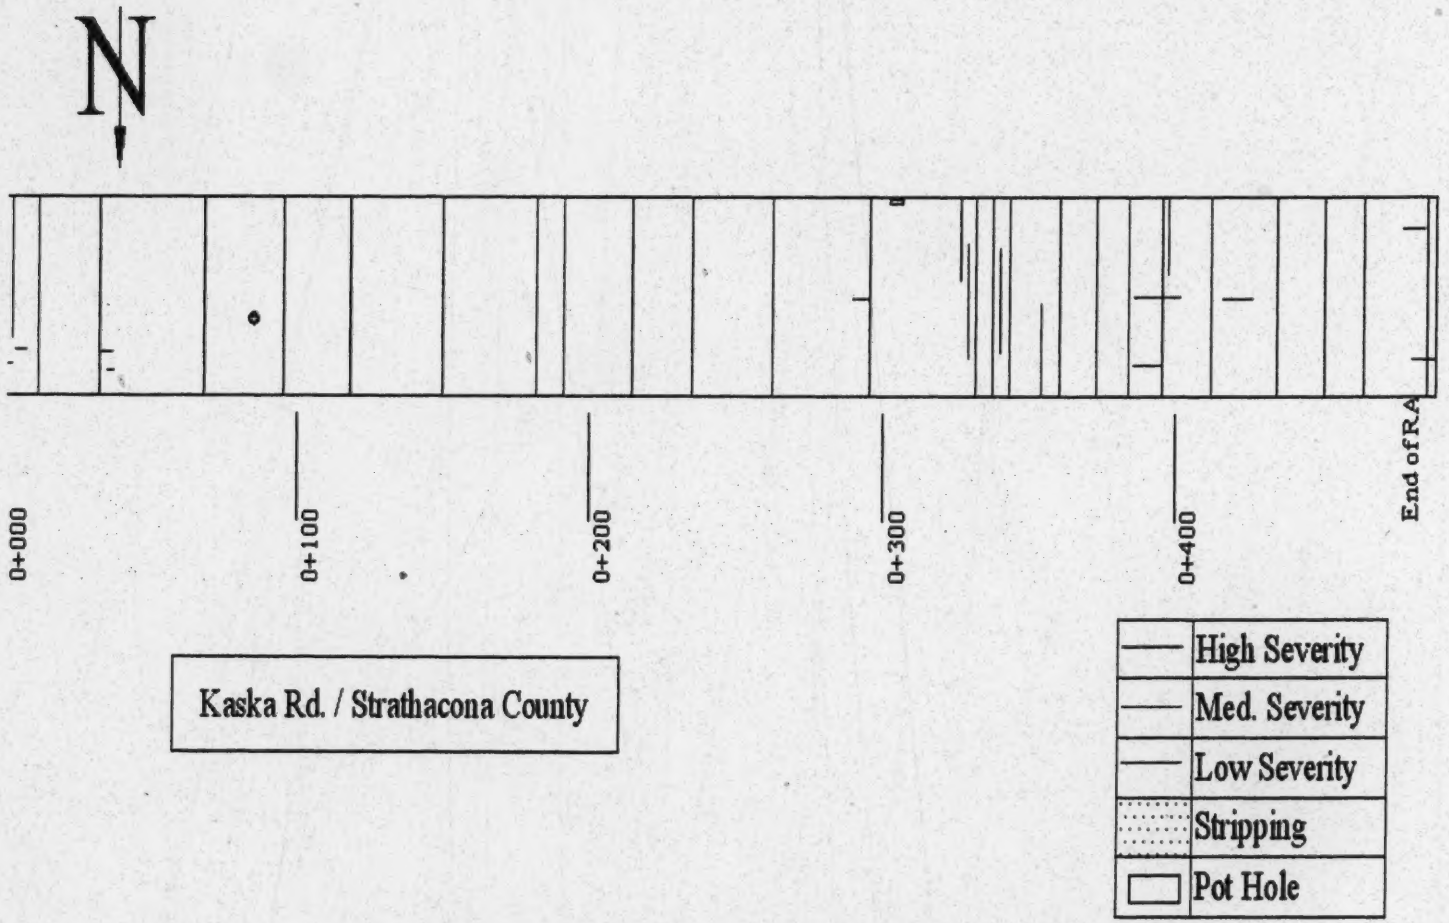
Figure 3.40 Crack measurements at Kaska Road project location

Most of the cracks observed at this project location were of low severity. However, some medium and high severity transverse cracks were also observed. The other form of surface distresses (ravelling, pot holes, patches, stripping) were not observed at this project location.

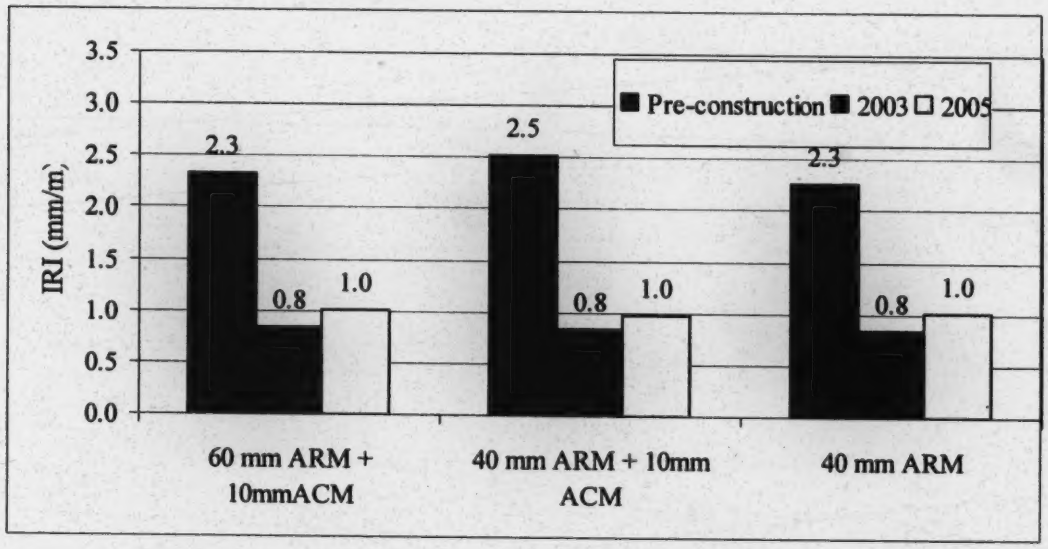
Figure 3.41 Summary of IRI measurement at the Highway 623 project location

The IRI measurement at this project location (for all pavement sections) is lower compared to the other project locations, which used the 2003 aggregate and the 2003 mix design. The increase in the IRI from 2003 to 2005 is also relatively small.

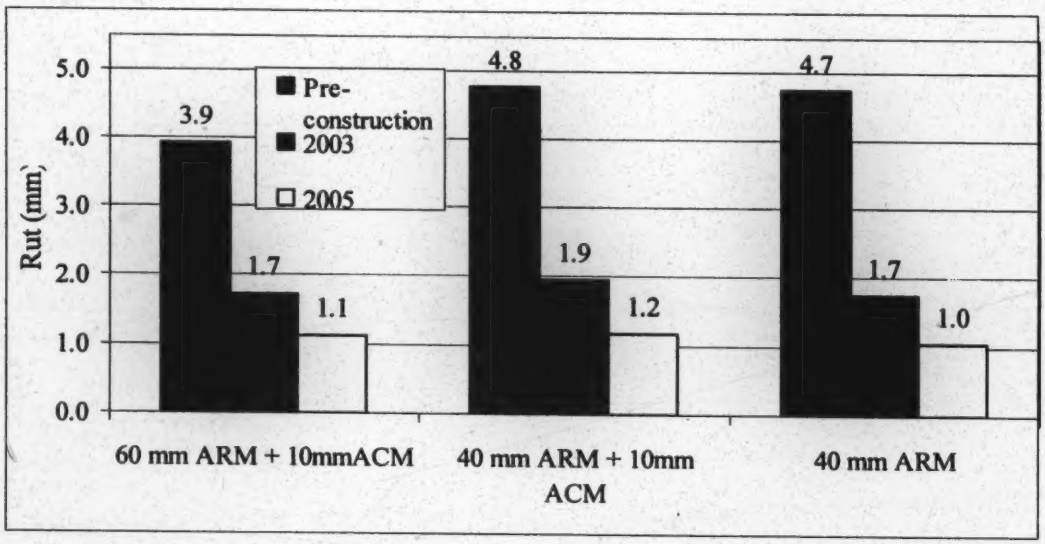
Figure 3.42 Summary of rut measurement at the Highway 623 project location

The rut measurement, however, is showing a decreasing trend like some of the other projects. This can be attributed to the fact that the accuracy of the measuring equipment is ±1 mm.

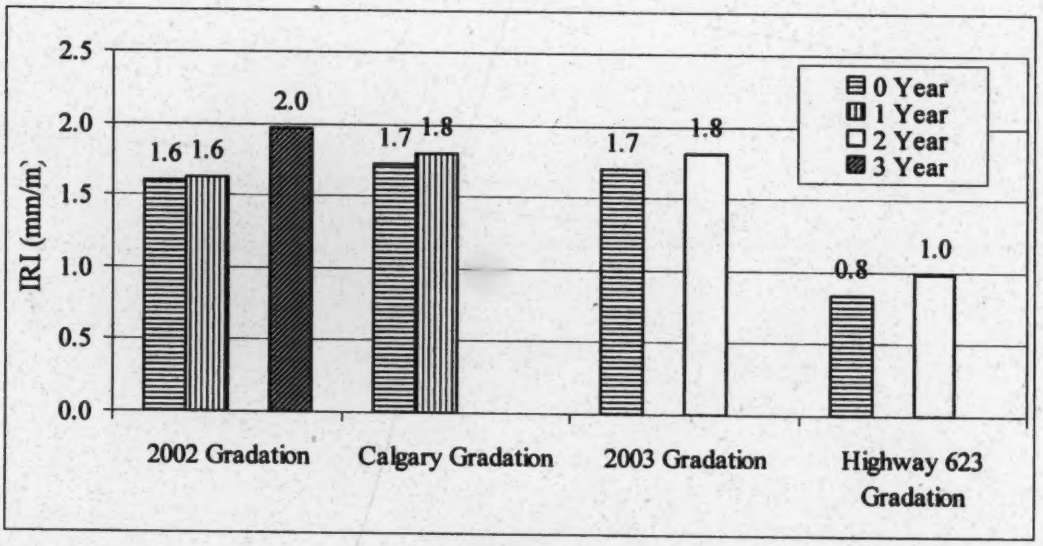
Figure 3.43 Comparison of the IRI for different aggregate gradation used in 2002 and 2003 Asphalt Rubber project

In the 2002 projects, the half thickness ARM overlays have performed inferiorly compared to the full thickness ARM overlays. Figure 3.43 presents the comparison of IRI

Based on the IRI comparison, the pavement sections in the Highway 633 project location have superior performance compared to pavement sections using other aggregate gradation. It is to be noted that the binder design for this project location was also different compared to other project locations. The performance of the project locations, using 2002 aggregate gradation (and mix design) and project locations using 2003 aggregate gradation (and mix design), is similar. However, other than the 50 Street project location the IRI performance of pavement sections using 2003 aggregate gradation and mix design was inferior compared to other project locations.

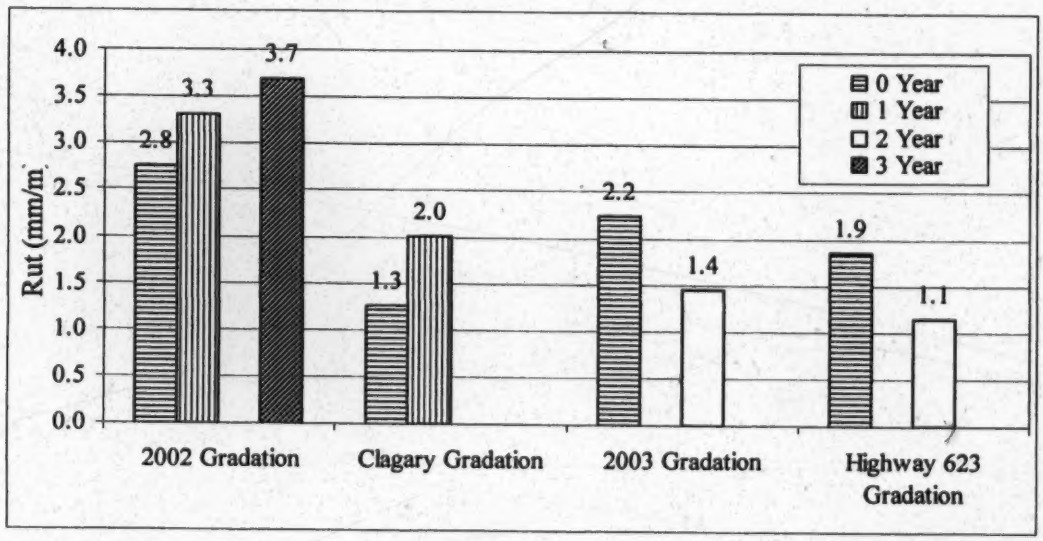
Figure 3.44 Comparison of the Rut for different aggregate gradation used in 2002 and 2003 AR project

The comparison was made based on the measurements from 2003. In the 2002 projects, except for the 112 Avenue project location, the half thickness ARM pavement have performed inferior compared to the full thickness ARM overlays from a rutting perspective.

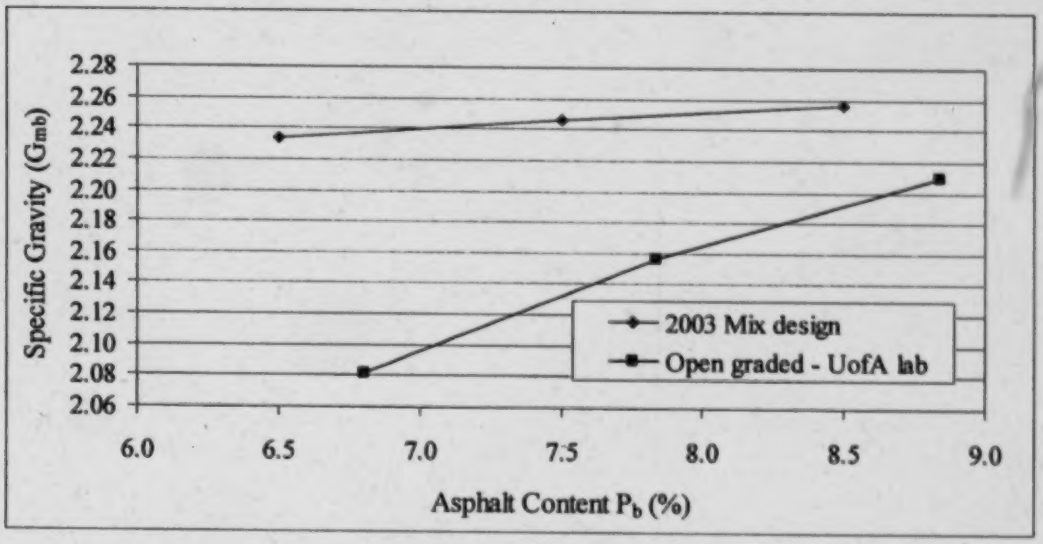
Figure 4.10 Comparison of G_{mb} measurement with Corelok with G_{mb} for 2003 mix design

It is clear from Figure 4.10 that G_{mb} values for the 2003 mix design were higher than the G_{mb} values for the mix design conducted at the University of Alberta. This difference may be attributed to the inability of the conventional method (AASHTO T166) to accurately determine the bulk specific gravity of samples with higher air voids due to excess water absorption. The use of Corelok Device, however, seals the sample with a plastic bag and does not allow any water absorption by the sample and, hence, can be considered more accurate than the conventional method for open-graded samples with excess air void.

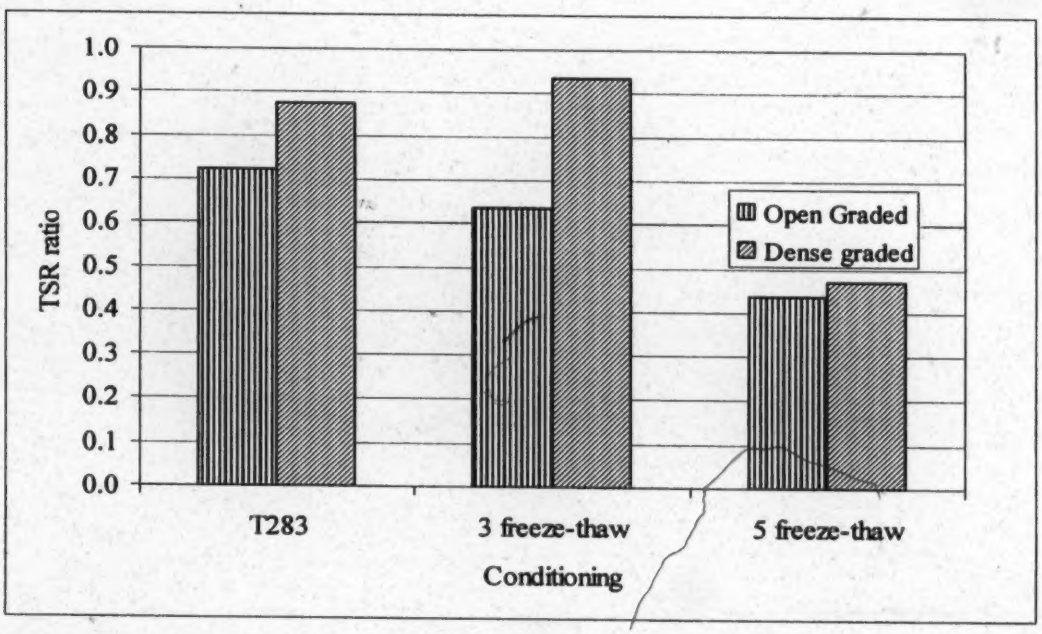
Figure 4.17 Results of moisture sensitivity test on open and dense-graded aggregate gradation

It is clearly seen from the results of the tensile strength test that the dense-graded gradation outperformed the open-graded sample for all moisture conditioning. The comparison of TSR values for sample conditioned for three freeze-thaw cycle shows a substantial difference between the open-graded and dense-graded ARM, thereby indicating dense-graded ARM to be favorable for harsh weather condition like the one in Alberta. It is to be noted that while conditioning the sample D8, the sealing was not effective and that in the last freeze-thaw cycle the entire sample came in contact with the water while thawing at 60°C. This might have influenced the tensile strength of the sample. If we discard the sample D8 from analysis, the difference in TSR ratio between open-graded (0.437) and dense-graded (0.639) ARM is substantial.
